Bridge 42 – Grosmont North Yorkshire

## Essential Maintenance Work- Bridge 42- Grosmont Planning Application

### Proposed repair work to B42 at Grosmont

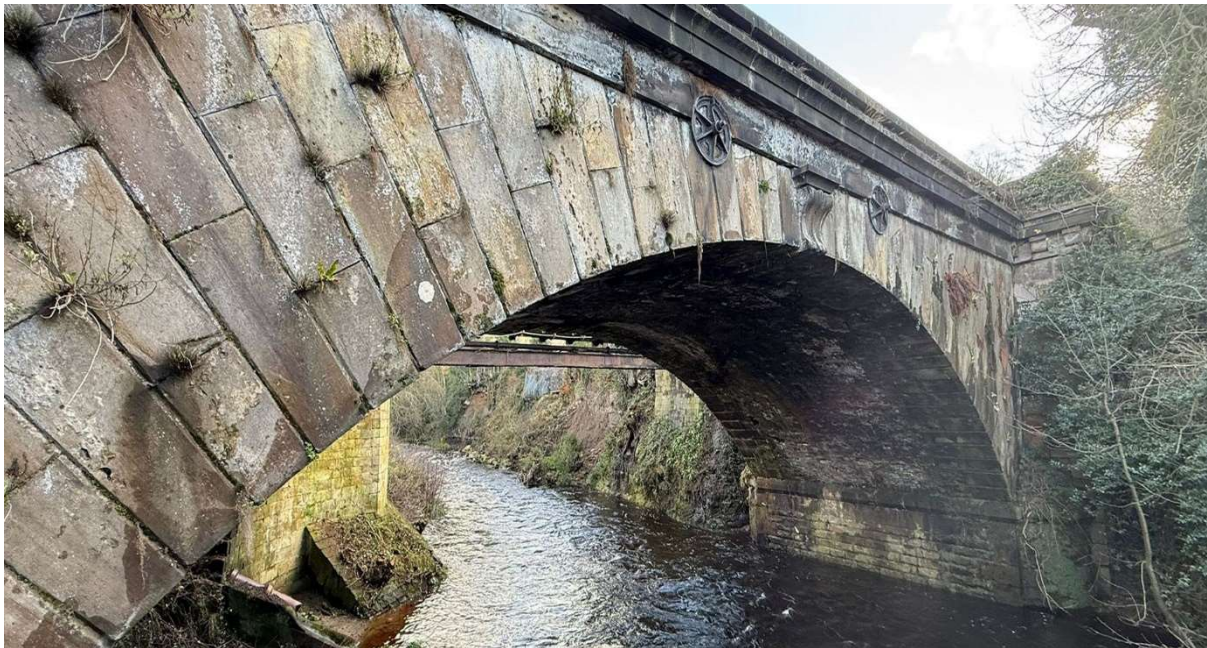
The structure comprises:

- Two outer stone masonry arch rings, each formed from approximately 50 masonry blocks with a uniform ring thickness of 1400 mm; and
- A central single-span, segmental brick masonry arch, spanning 18.5 m with a mid-span rise of approximately 4.2 m. The brick arch has a ring thickness of 900 mm, constructed in seven layers and comprising approximately 30,000 bricks.

The effective overall bridge width is approximately 9000 mm.

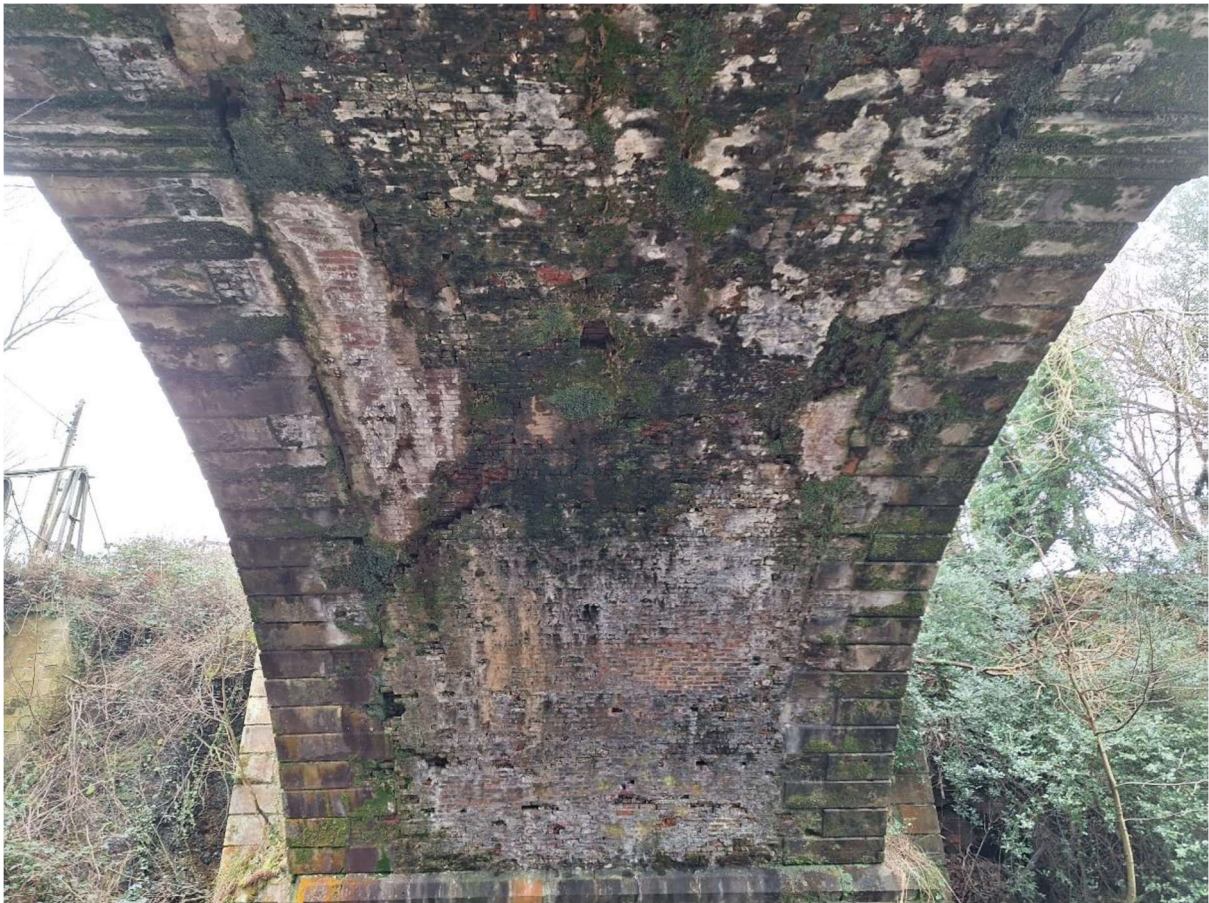
Underside of B42- Photo 1

This photograph shows that the outer layer of the archway has separated from the next inner layer and that areas of the outer skin are now missing.

#### Hollow brickwork methodology:

- Temporary works in the form of sprung steel irons are placed following the profile of the Arch fixed in place using 12mm steel threaded stud anchored using injected resin and pull tested.
- The brickwork is broken out by mechanical means using battery operated breakers ensuring that no more than 1M2 is removed at any time.
- The area has all loose material removed and is then damped down to ensure good adhesion of the sand/cement/lime mortar (to allow movement) and new to old brickwork.
- The bricks are laid with each course held in place by a 50 x 50 timber lagging and forced back to the profile of the Arch with timber wedges.
- The process is then carried out on the next 1M2 patch until the affected area is repaired.
- The temporary works (irons & laggings) remain in place for 7 days until the repair strengthens and then these are removed.

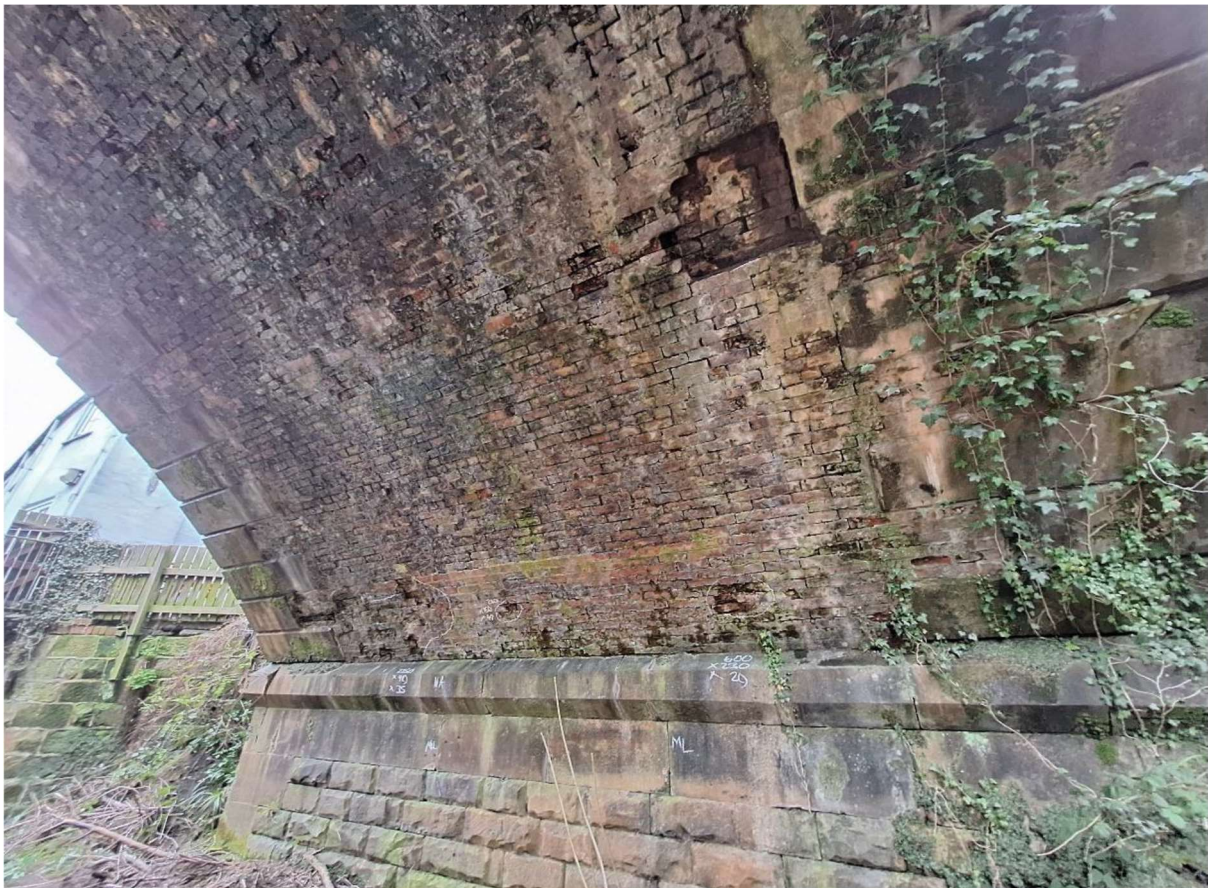
Underside of B42- Photo 2

This photo shows that the original shape of the archway has been retained and that the archway needs re casting to reinstate the overall integrity of the archway.

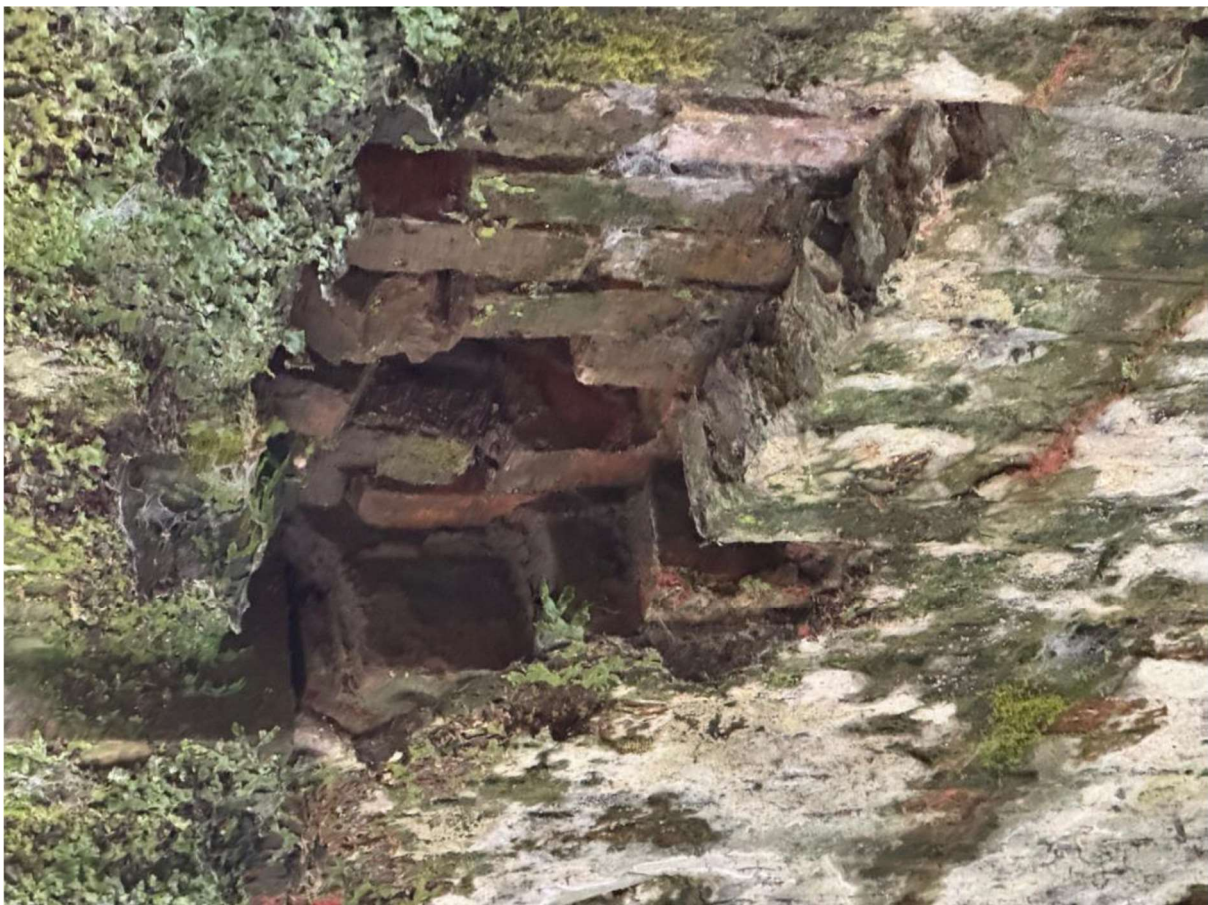
Underside of B42- Photo 3

This photo shows the localised delamination of the archway layers at this location both layer 2 and 3 of the 6-layer masonry brick ring are exposed.
